## SITE INSPECTION REPORT

LEASE # ML 47718

DOGM File # S/015/080

Project Name: "Black Knight Mine"

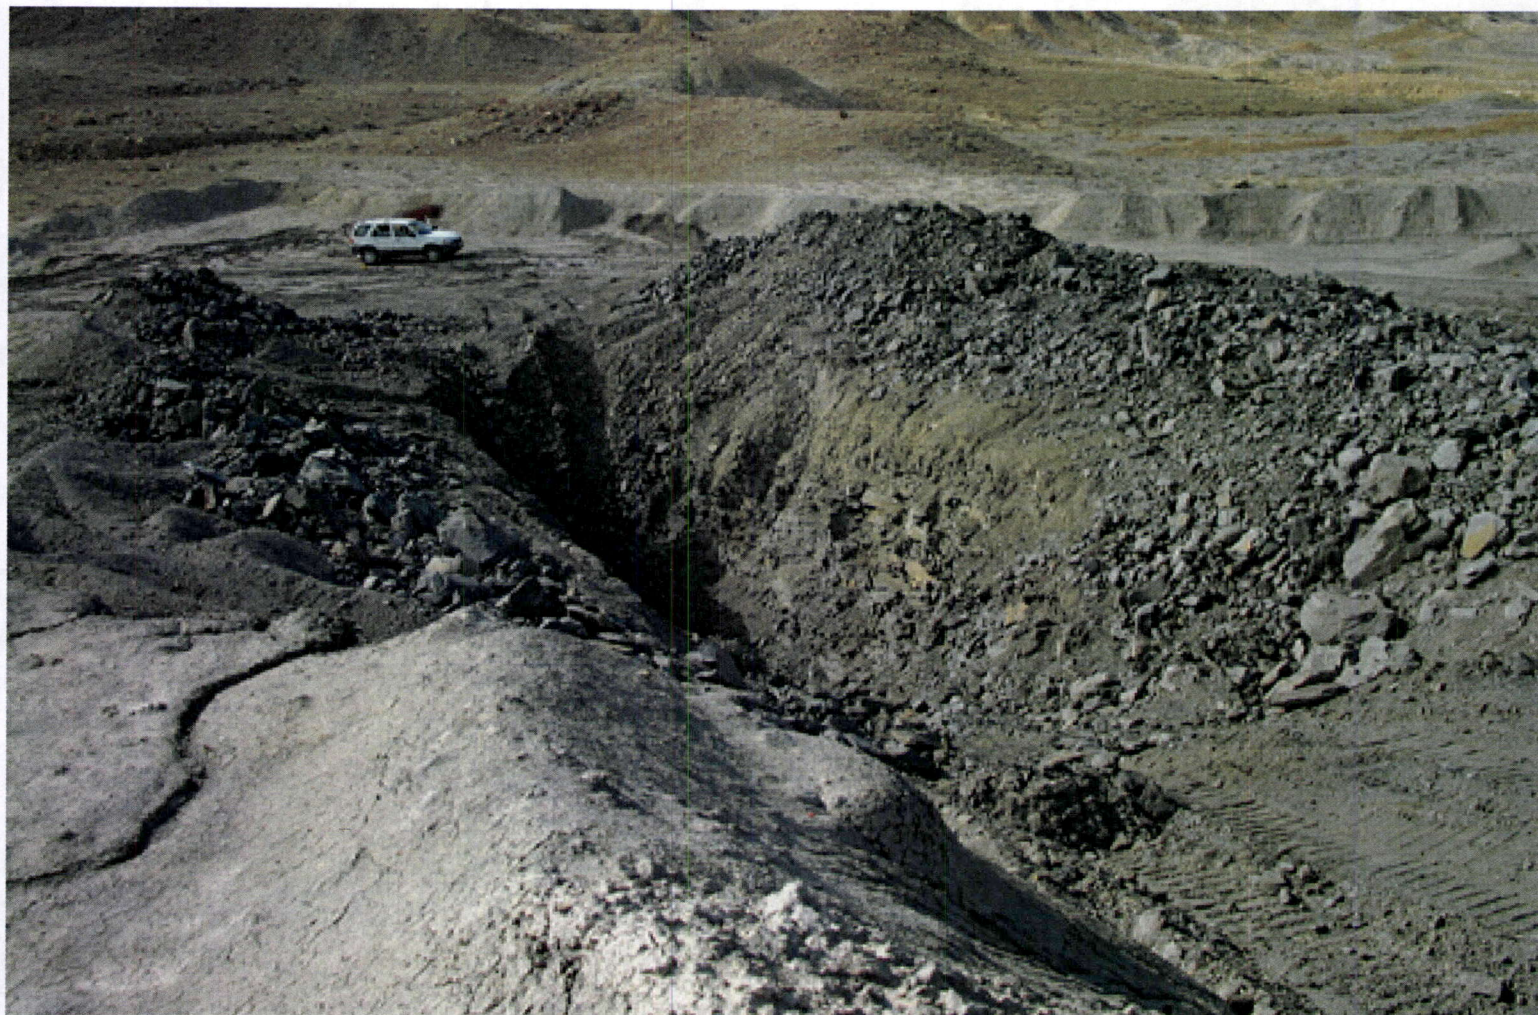
The mine related surface disturbances consists of an open pit and a leveled area adjoining the south side of the pit. The leveled area is buried by piles of overburden that is presumably the surface soil saved from the mine site. The mine pit is approximately 25 feet deep and is depicted in the captioned photographs accompanying this report. As mentioned in my surface examination report of June 28, 1999, the undisturbed mine site was essentially devoid of flora so it is unlikely that saved surface soils, when redistributed, will enhance re-vegetation. The area of disturbed land attributed to the mine site was determined by pacing the average width and length of the disturbance. The disturbed land encompasses an area that is approximately 105 feet wide and 300 feet long or approximately 31,500 square feet or 0.73 of an acre.

Looking south, from the top of a large overburden pile, onto the main pit area. The pit is approximately 25 feet deep.

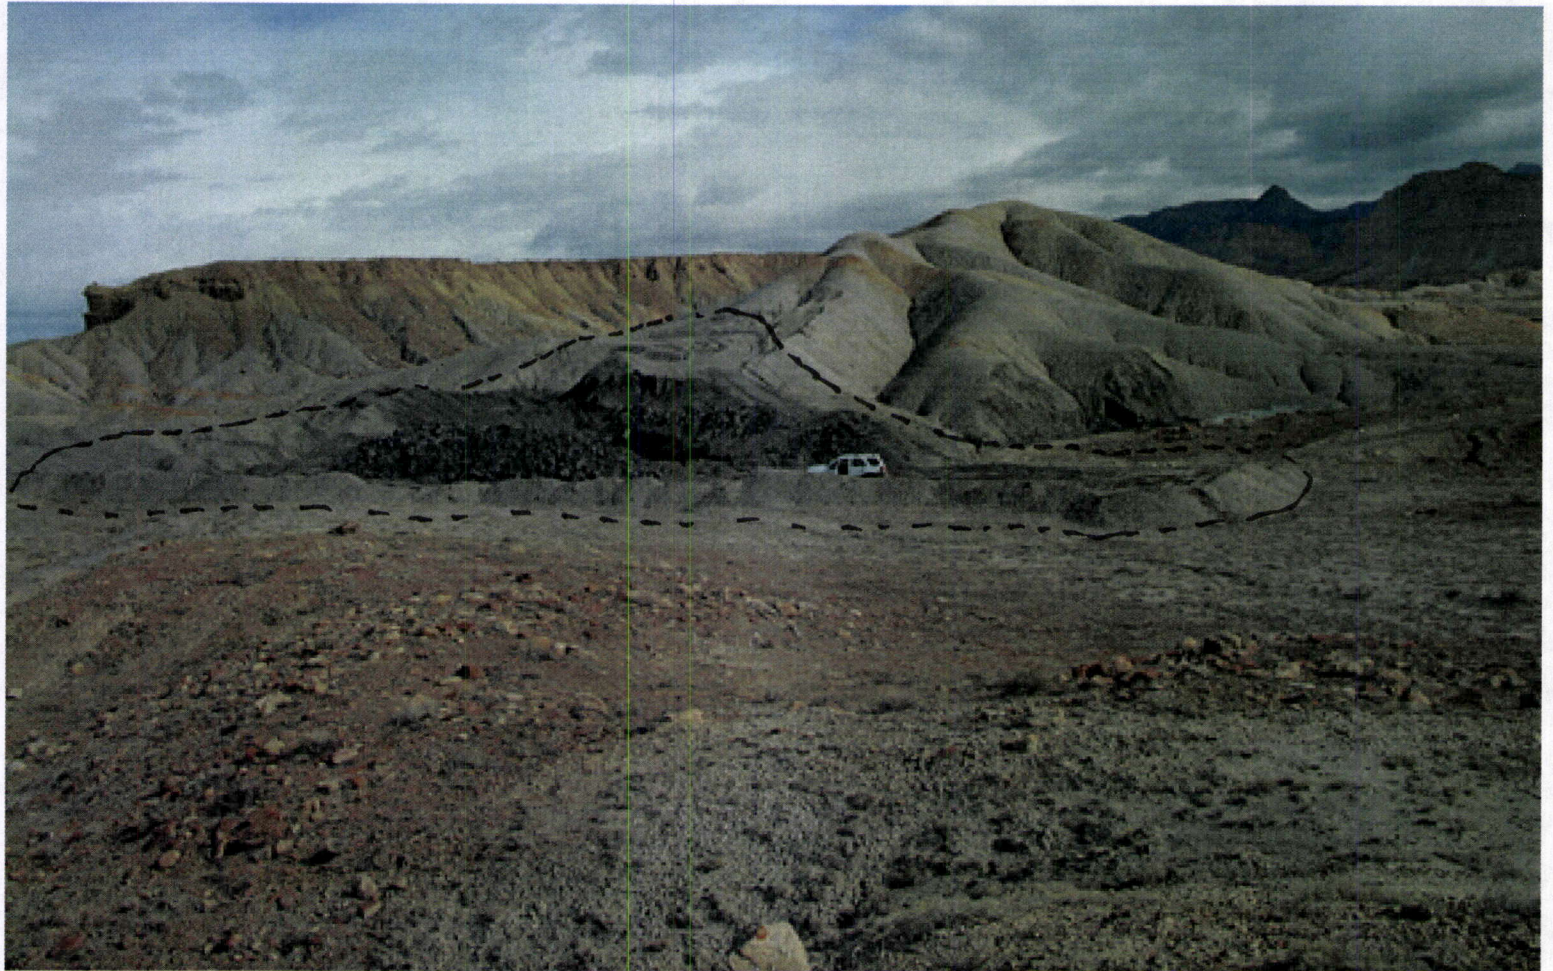
Looking north onto the entire disturbed area. This photo was taken from the top of the small hill that can be seen in the top center of the previous photo.
